Case report

FRACTURE OF THE SURGERY TABLE PRIOR TO PERFORM A TUBAL LIGATION ON A PATIENT

This paper reports the case of a patient about to undergo a tubal ligation; after inducing anesthesia, the surgical table where the patient lay in a state of deep sedation and analgesia fractured, exposing her to a fall. The patient did not suffer any injury and it was determined that the cause of the fracture was the wear of a support piece of the surgical table, which is considered material fatigue.

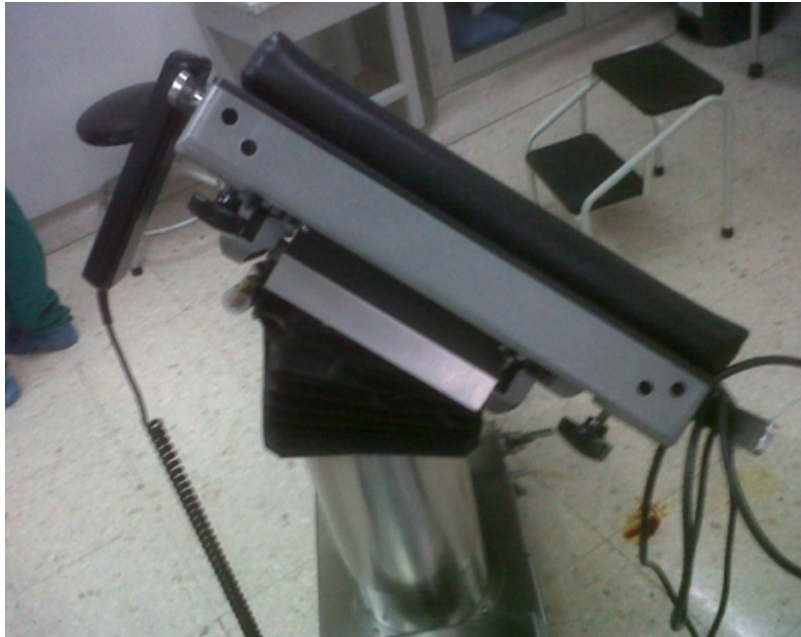
Fig 1. Condition of the operating table after the fracture.

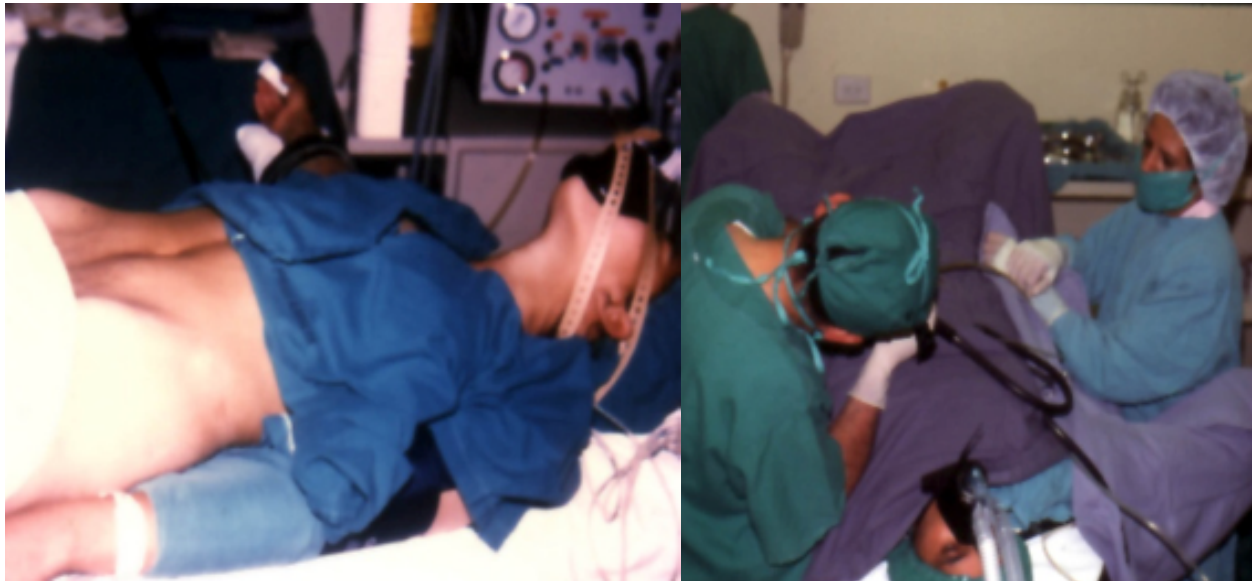
Fig 2. Position of the patient for tubal ligation.

“The patient is placed in lithotomy position, with the superior left limb placed next to the body on the operating table and the left hand in supination (see Figure 2). The superior right limb remains in abduction of 90°

or less, on an armrest, with the right hand in supination. In this situation, it is considered that the ‘team must accommodate to the patient and not the patient to the team’, therefore, nurses and anesthesiologists can be confident that the patient does not feel any abnormal pressure over the nerves or joints, nor exaggerated traction on any of her four limbs.” (5)

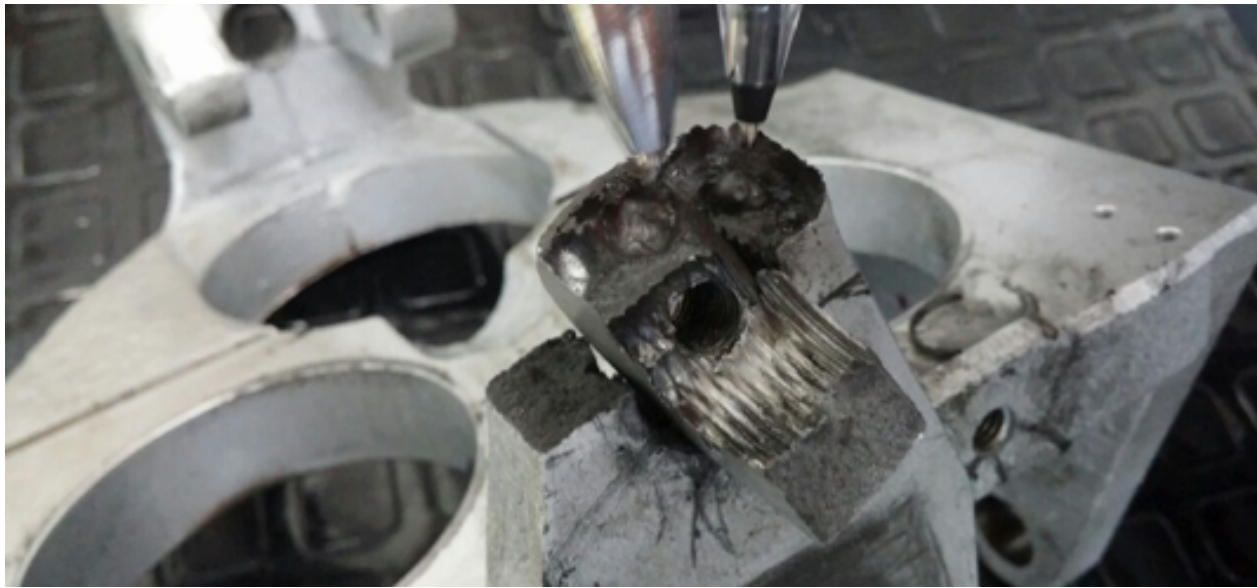
The revision of the data for this operating table revealed that its brand was Trident, made in Taiwan, Model Novel S.5600, electro-hydraulic and that it was acquired in October, 2008. Regular maintenance was performed by the electro-medical staff every four months. The main support of the table probably broke due to material fatigue (excess of cumulative weight and frequent changes of position, repetitive Trendelenburg movements and posterior neutral position, besides reaching its maximum height about 15 times a day on average), which is inferred based on the diagnosis performed by the engineers who concluded that the mechanical wear of the piece that belongs to the central support and the failure in the melting of the piece (a bubble in the metal piece can be seen) generated the fracture (see Figure 3).

Fig 3. Image of the bubble in the piece of the surgical table.

Frequent monitoring of the state of all devices and elements that will be used on patients and taking preventive measures to avoid events such as falls during the perioperative period are suggested.

The fracture of a surgical table during the perioperative period is a highly rare incident that may imply serious consequences for the patient, therefore, the surgical team must take preventive measures to disregard material fatigue and develop a guide to prevent and manage patient falls.
