Subsoil geophysical evaluation using GPR and free software

Hernán Darío Guerrero, Luis Hernán Ochoa
Universidad Nacional de Colombia

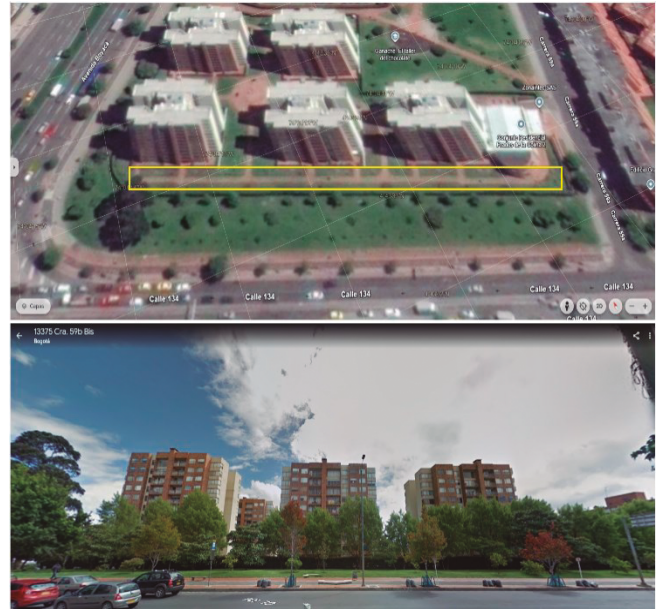
Figure 1. Location Overview of the Study Area. The top image, captured in 2015, shows the site where the geophysical investigation was conducted, located to the south of the building complex. At this time, the trees were still small, and no damage had been reported within the platforms. The yellow rectangle highlights the study area. The bottom image, taken after 2020, shows the same location with significantly larger trees, whose growth coincides with the structural damage reported inside the platforms.

The data acquisition was carried out in a residential complex located in the northwest of Bogotá - Colombia, which can be seen in the Figure 1.

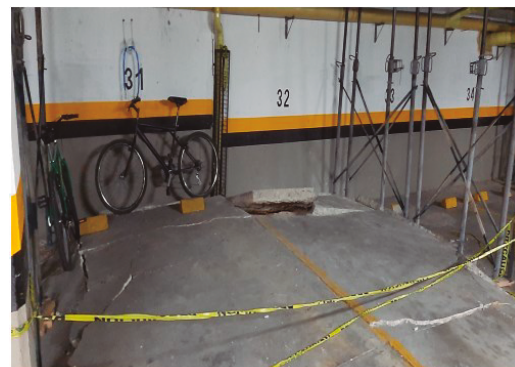
Figure 3. A rise is observed in the parking slab. The thickness of the slab is 15 cm. Several fissures and cracks have been formed.

The circulation slab at the south side of the residential complex has multiple damages on its surface. The subsoil below: this area is being affected by something that causes large sags and lifts to occur, breaking the reinforced concrete and causing considerable damage to the structure in question, see Figures 2, 3. The retaining wall also presents damage. This indicates that some elements of the structural system of beams and columns that lead up to it has been affected, with cracks and fissures in these elements.

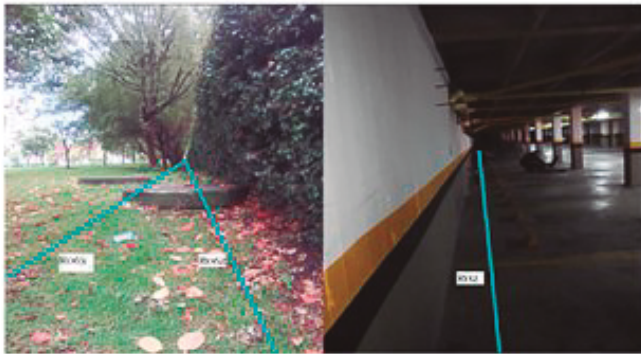
a) Topographic profile

b) GPR Acquisition lines next to the retaining wall

Figure 4. Panoramic view of the zone. Figure a. shows a topographic profile of the section between the wall and the tree line. Figure b. shows the GPR lines acquired outside the wall and inside the basement immediately next to the wall. The difference in height between the profiles taken at (a) and (b) is 2.5 m.

There are two lines of trees close to the retaining wall (Figure 4). The tree line that corresponds to the weeping willow line is at a distance of around 2 - 3 m. from the retaining wall. There are fifteen (15) of those trees spread almost evenly along the 150 m of wall, with a height of around 13 - 16 m. on average. The second line of trees is far from the Weeping Willows (more than 3 m.) and corresponds to another tree species of lesser size.

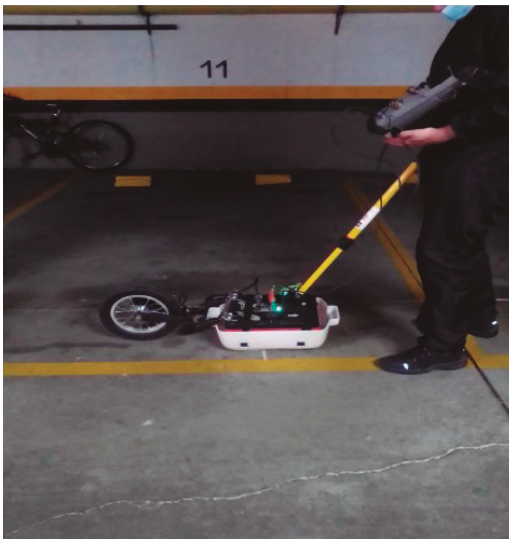
Figure 5. Position of the GSSI 350 HS antenna and the GPR GSSI Sir4000 during the acquisition, on the reflection profile mode.

In this work, a GSSI Sir4000™ was used in conjunction with a 350 HS™ antenna (see Figure 5). The SIR 4000 (GSSI, 2017) is GSSI's first high-performance GPR data acquisition system designed to work with both analog and digital antennas. This evolutionary step allows for true versatility and flexibility in supporting a wide range of users in numerous applications. The HS 350 MHz central frequency (GSSI, 2013) is a next-generation digital antenna designed to work seamlessly with the GSSI SIR 4000 control unit and the G1 controller. It is easily configurable to suit any kind of application, including archaeology, geophysics, utility location, and more. GSSI's Hyper Stacking technology considerably improves the depth and performance of data resolution compared to traditional radiated two-stage methods.

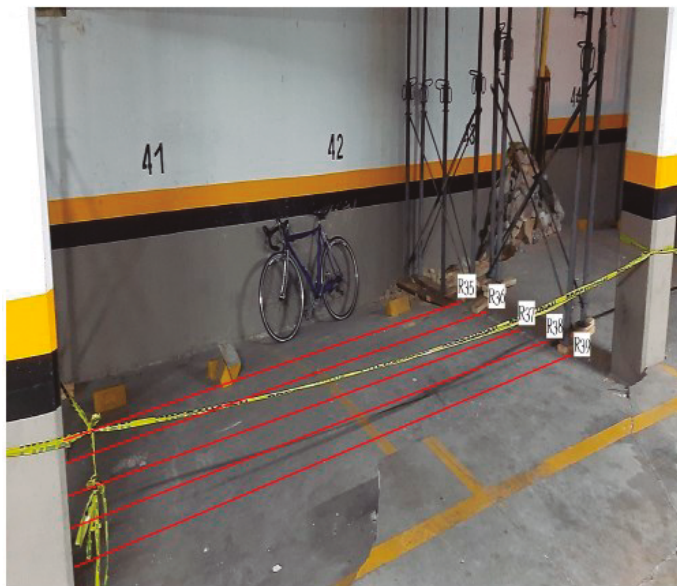
Figure 7. Location of the short profiles acquired in the basement at parking lots 41 - 42. Trajectories where profiles were taken are outlined in red. Note the great alteration in this parking lot, which shows a fairly large subsidence, as well as many cracks.

Considering the structural damage in the parking slab visible on the surface, due to either subsidence, uplift, or fissures, much denser short profiles were made for each affected area, that is, five GPR profiles were taken separated fifty cm from each other (Figure 7).

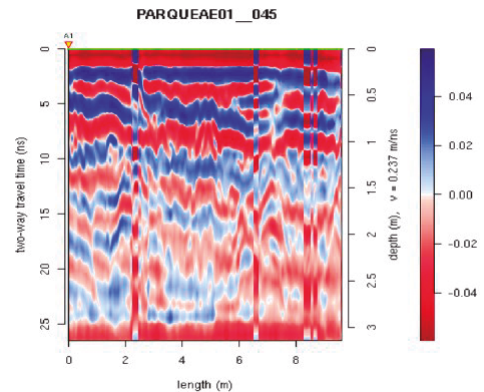
Figure 11. The picture displays the data after the median filter was applied in RGPR.

Several scripts in RGPR were written to perform all steps for processing GPR data, in accordance to the literature and in order to get the best results. Below, we show some of these results to evoke how the output is displayed in the software mentioned (Figures 9, 10, 11).

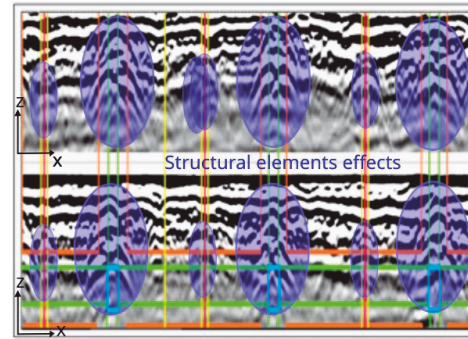
Figure 13. Small section extracted from a larger radargram. This is agreement between detected anomalies and the building's structure. The pictures show two radargrams sections, The anomalies detected in the subsurface have been enclosed in blue ellipses to highlight them. These anomalies correspond to various structural elements, which are marked in different colors for easier identification. The radargrams has beams (green), foundation beams (green), flooring joist (orange), and filters (yellow with red). (x) axis is lateral distance in meters and (z) is depth in nanoseconds.

Figure 13 shows a close-up of the concordance of GPR events with the structural and plumbing elements of the building, which are fully identified and shown in Figure 14. Similarly, there are more structural and plumbing elements in (Figure 13) that are precisely identified with the interpreted GPR anomalies.

The previous image (Figure 13) displays a small section extracted from a larger radargram. It highlights key elements, including columns (cyan), flooring joists (green), and filters (yellow), along with the corresponding annotations for trees (green). This zoomed-in view facilitates a focused examination of the structural components and their arrangement within the radar data. There is a strong correlation between these anomalies and the structural elements of the building. For a more detailed analysis, please refer to the complete radargram (see Figure 14), from which this section has been extracted.

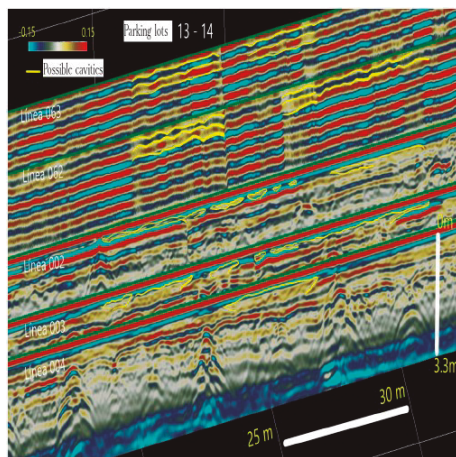
Figure 16. Overview of radargrams analyzed in OpenTect around 20–30 m. The profiles display R063 and R062 (outside the wall) at the top, followed by R02, R03, and R04 (inside the wall). Disturbances in the subsoil highlight the correlation between internal and external areas in sections where Weeping Willows are present.

The anomalies detected in the subsoil beneath the parking lot are clearly shown Figures 16, 17, 18, 19 and 20, following the previously described methodology and excluding those attributable to structural and plumbing elements. Each of these figures is marked to highlight the affected areas observed. In this study, the analyses were carried out by dividing each profile into segments of a few meters, as indicated in the aforementioned figures. Additionally, a detailed analysis was conducted for each case where surface damage was evident. For example, Figures 16 to 20 present a three-dimensional visualization of the radargrams, with each radargram positioned according to its respective acquisition location, in Figures 16 and 17, it is clear that the alterations in the subsoil coincide with the proximity of trees to the damaged surface areas. These correlations are documented across all cases, as seen in Figures 18, 19, and 20, where the affected areas show consistent patterns near the trees. This analysis reinforces the interpretation that trees play a key role in the observed damage, a common occurrence when soil desiccation is induced by tree roots. The relationship between root expansion and soil drying often leads to structural issues. Moore and Ryder (2015) highlight that such impacts are significant in assessing the effects of tree roots on their surrounding environment.

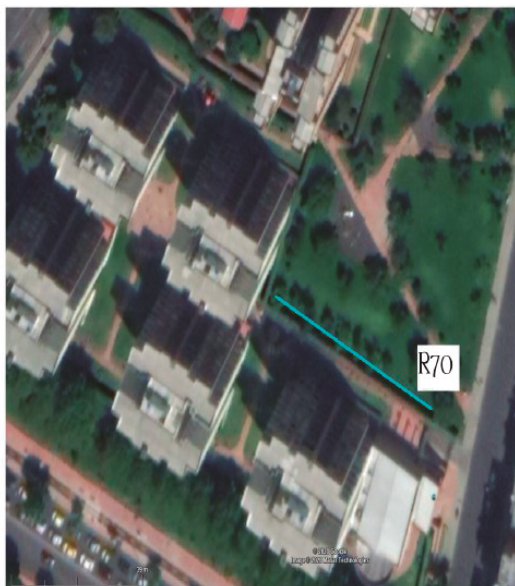
Figure 21. Radargram R070. No disturbance due to roots is observed. This radargram was obtained in the external northern area of the basement where there is no presence of Weeping Willows.

Figures 21 and 22 show examples of a radargram taken in an unaffected soil zone (Radargram 070). This location corresponds to the northern part of the complex. In this place, there is no presence of Weeping Willows.

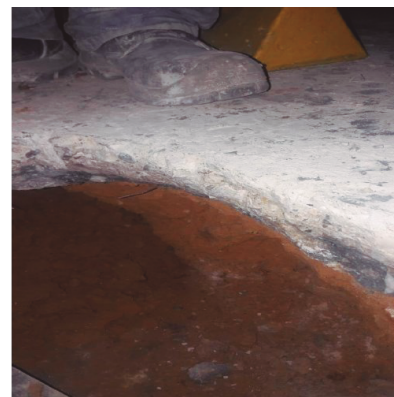
Figure 23. Evidence of scour. It is difficult to estimate the size of the scour, but it is seen to be elongated, which is consistent with what is observed in the GPR records. The exact position of the pit is unknown but is located at the foot of the retaining wall.

A photographic record obtained from a person associated with the building provides compelling evidence of cavities (Figure 23). These cavities, visible long before the commencement of this study, indicate the onset of surface issues. The presence of a pit at the foot of the retaining wall correlates directly with these surface problems, demonstrating that the initial disturbances were exacerbated by the growth of tree roots in the vicinity. The expansion of these roots can induce soil desiccation, further compromising the structural integrity of the surface (Moore and Ryder, 2015). Moreover, the observed depressions align with the findings in the radargrams, establishing a consistent relationship between the surface manifestations and the anomalies detected in the subsurface. This reinforces the conclusion that the initial surface disturbances, influenced by the growth and desiccation effects of tree roots, significantly contributed to the formation of these cavities, as substantiated by both photographic documentation and radar analysis.
