Environmental problematics associated with anthropogeomorphologic activities: the case of Chia in the savannah of Bogotá, Colombia

Miguel-Angel Castiblanco-Sierra^a

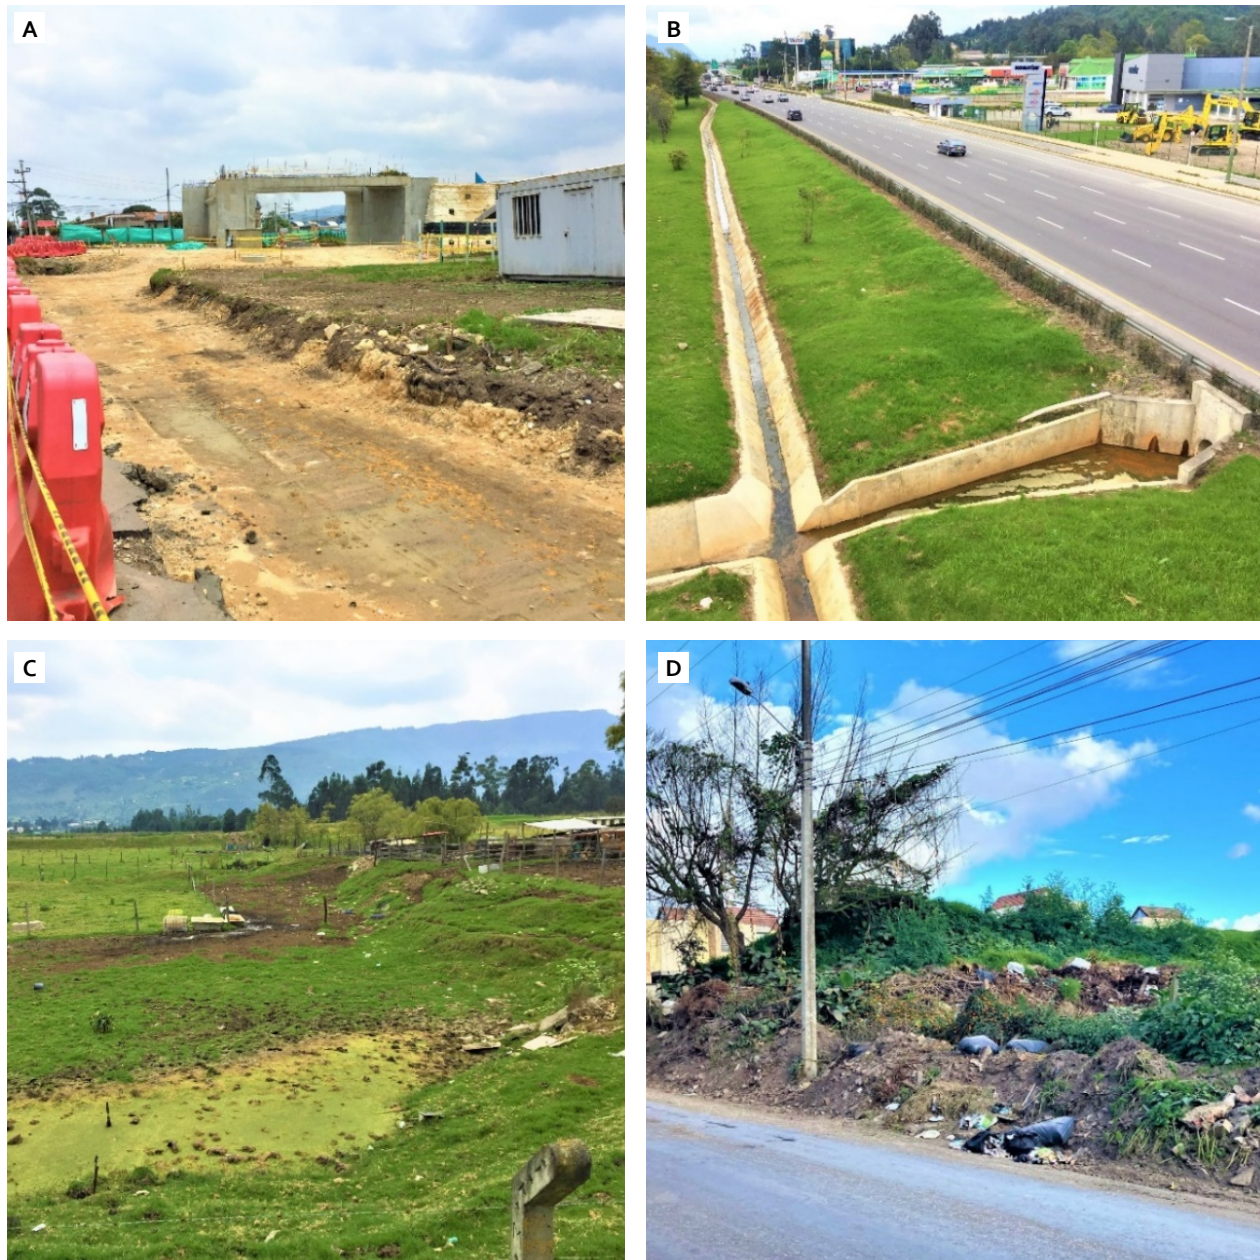
Figure 4. Impact scenarios **A:** Elimination of soil due to construction of road infrastructure. Sector Rincón de Samaria, town La Balsa (2021). **B:** Scoring of the surface runoff, waterproofing, and burying of soils due to road works in the North Highway. Sector Colegio Odontológico, town Fusca (2021). **C:** Drain, ecosystem alteration, and contamination of the wetland due to progressive stuffings. Sector La PTAR I, town La Balsa (2021). **D:** Contamination due to disposition of dump in mounds

Note. Sector Vivenza, town La Balsa (2020).

Environmental impacts associated with interventions are numerous and complex; however, from the analysis, five main categories were established to group them. They are described on Table 2 and exemplified with some cases on Table 4.

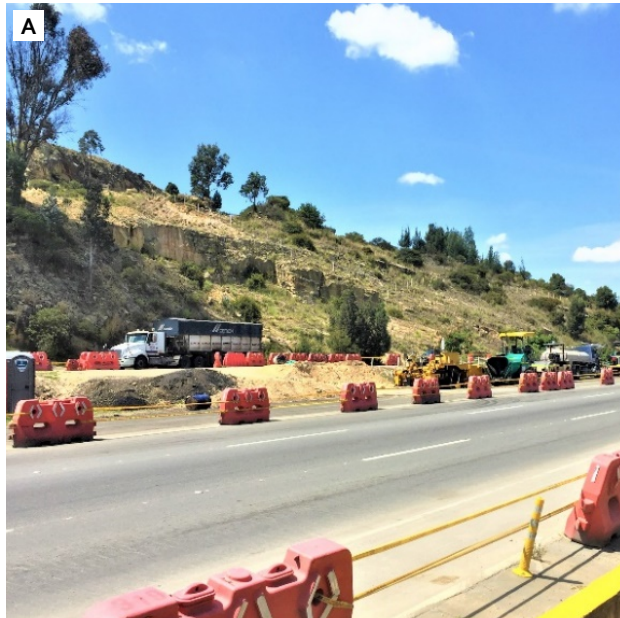
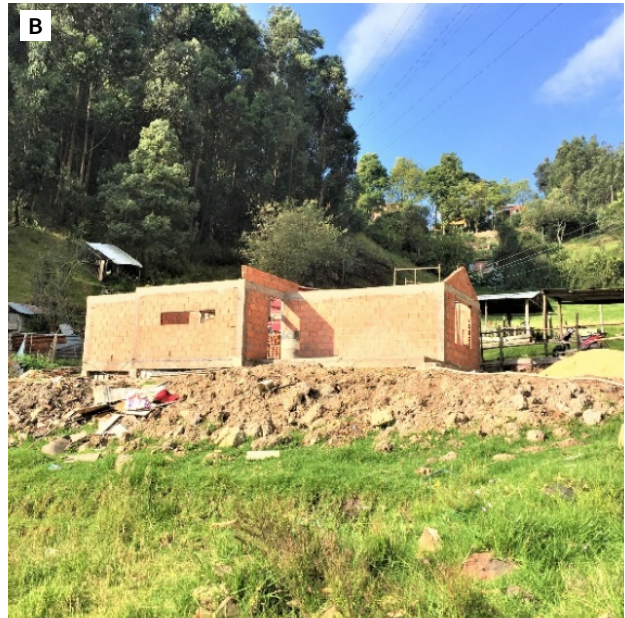
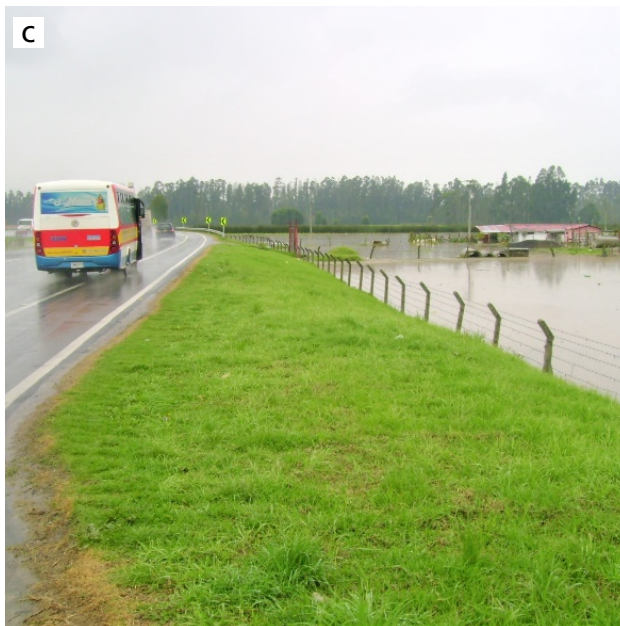
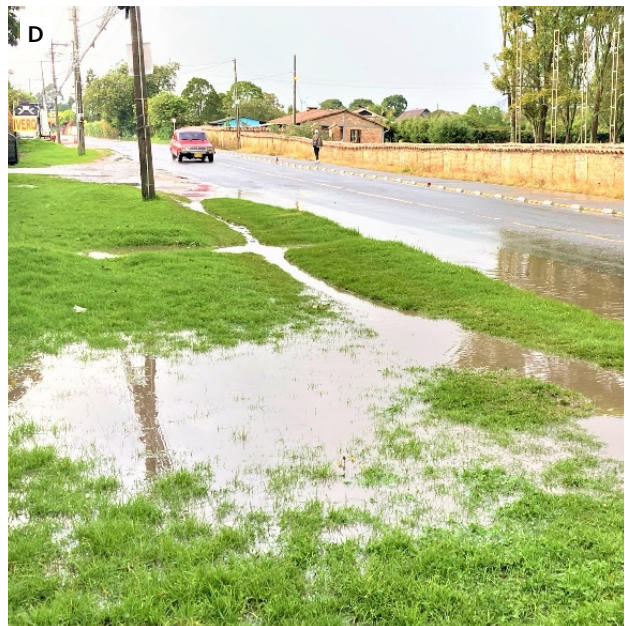
Figure 5. Risk scenarios. **A:** potential risk of mass erosion and removal due to quarries and routes. North Highway, sector La Resaca, town Yerbabuena (2021). **B:** Incorporation of unstable rubble on high gradient slopes. Sector La Valvanera, town Fonquetá (2021). **C:** Changes in the dynamics of fluvial overflows due to construction of highway banks in flooding basins. Bogota river valley, sector Teletón, town Fusca (2021). **D:** Puddly floodings generated by rains in urban growth zones, sector La Virgen Source Town La Balsa (2021)

the population of the municipality and their goods due to the population growth and expansion. The creation, increase, or control of risk states and conditions are described on Table 3, with some photographic examples outlined in Figure 5.

Risk	General description and references
Due to mass removal	Landslides, erosion, and their affectations can increase due to interventions, mainly of quarries, road cuts, and dumps disposed on the steep slopes of the mountain (Figures 5A and 5B), with changes in the natural vegetal covering that protects the hillside, intensive use of soil, deficiency in the infrastructure works, inadequate movement of materials, and increase of surface runoff during rainy periods. (Alcaldía de Chía, 2020a; Burgos and Reina, 2015; Poloche, 2015).
Due to flooding lentas	Floods, slow overflows, and prolonged waterlogging are influenced most frequently by human interventions. In Chia the inadequate disposal of materials in floodplain environments has been common, with the reduction of the buffer zones (wetlands) (Figure 5C), elimination of meanders, soil waterproofing, collapse of the sewage system (Figure 5D), and in general the improper occupation of hydric rounds (Afanador, 2019; Ávila et al., 2015; Burgos and Reina, 2015; Castro and Zambrano, 2019; Mejía and Chicué, 2014). In contrast, and as an exception of the problematic typical of overflows, hydraulic works in dams and riverbeds carried out by the environmental authority has avoided flooding events (CAR, 2018b); however, there still is uncertainty regarding their effectivity and the harmful environmental effects of these interventions (Durán and Suárez, 2013; Semana, 2020).
