Influence of Thermal Aging on the Sliding Wear of a Biocomposite Material Reinforced with Bamboo Fibers

Eudi Blanco¹, Jorge I. Fajardo², Edwuin J. Carrasquero³, Caribay Urbina⁴, Luis M. López⁵, and Luis Cruz⁶

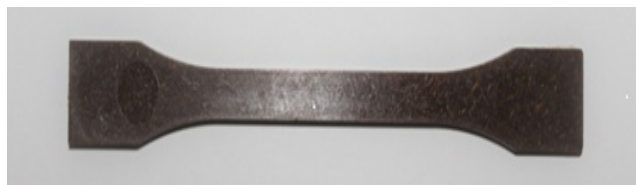
Figure 1. Type 1B 527 ISO standardized specimen (ASTM D638-14) made of PP/20F biocomposite, from which the samples for the study were extracted

Composite processing

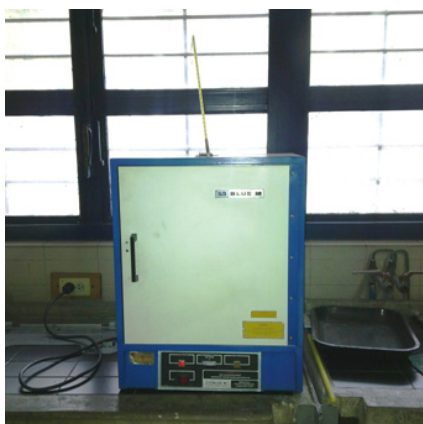
Figure 2. Gravity convection oven used to perform the accelerated thermal aging test

A group of raw PP and PP/FB samples were subjected to a thermal aging process by continuous heating at 98 °C for 10 days using a BLUE M SW-11TA-1 gravity convection oven (Figure 2). Subsequently, the samples were removed from the oven to cool to room temperature. The temperature selection for this heat treatment was based on its proximity to the continuous-use temperature of homopolymer polypropylene (100 °C).

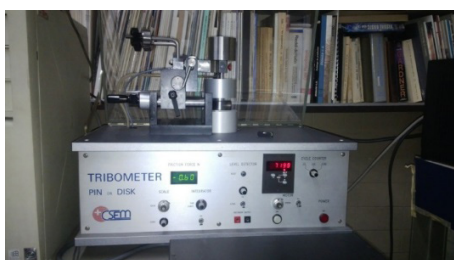
Figure 3. Tribometer used for the study of sliding wear

The tribological study of PP/FB composites was carried out via sliding wear tests, according to ASTM G99-17 (ASTM International, 2017). These tests were carried out on a standard CSM Instruments tribometer (Figure 3), under the Pin-on-Disk configuration, which consisted of sliding a stationary pin (which acts as a support for the sphere or ball) against the surface of the sample under study coupled to a rotating disk (Figure 4). This equipment includes software-rolled relative humidity of $70 \pm 2\%$. The sliding conditions were as follows: 31 836 cycles, equivalent to a total sliding distance of 600 m; a linear sliding velocity of 15 cm/s; and an applied normal load of 10 N. The static counterparts used were 6 mm diameter spheres of AISI 52100 steel.

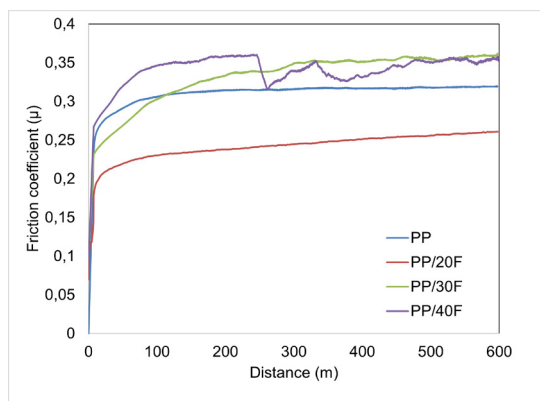
Figure 5 shows the variation of the friction coefficient (μ) with sliding distance for raw PP and PP/FB biocomposites. The friction value increased during the initial phase of wear, which is due to the increase in the contact area between the polymer and the metallic counterpart. Thereafter, it stabilizes and follows a steady state behavior.

Figure 5. Variation of the friction coefficient (μ) with the sliding distance
Source: Authors

fluctuations of μ are obtained when PP is reinforced with bamboo fibers, and that these fluctuations increase when the number of fibers in the polymeric matrix is increased. Inadequate fiber distribution or mixing at a higher ratio (40 wt%) may cause structural discontinuities in the composites and thus result in higher friction variability. Meanwhile, at a lower ratio (20 wt%), homogeneity in the mixture could have been achieved, resulting in high friction stability (Singh et al., 2019), as observed in Figure 5.

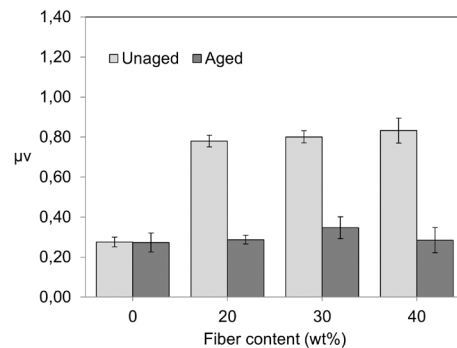
Figure 11 shows a comparative plot of the friction coefficient of variability (μ_v) of the aged and unaged samples. The aged PP/40F composite exhibited a greater decrease in μ_v (-65.8%) than the unaged sample, i.e., for the PP/40F composite, aging significantly improved the stability of the friction coefficient values, which is evident in Figure 10d.

Figure 11. Comparison of the coefficient of friction variability (μ_v) of aged and unaged PP and PP/FB samples
